Lining the Open Sea

Monterey Bay Aquarium Improves the Illusion of its Largest Tank

By Steven H. Miller

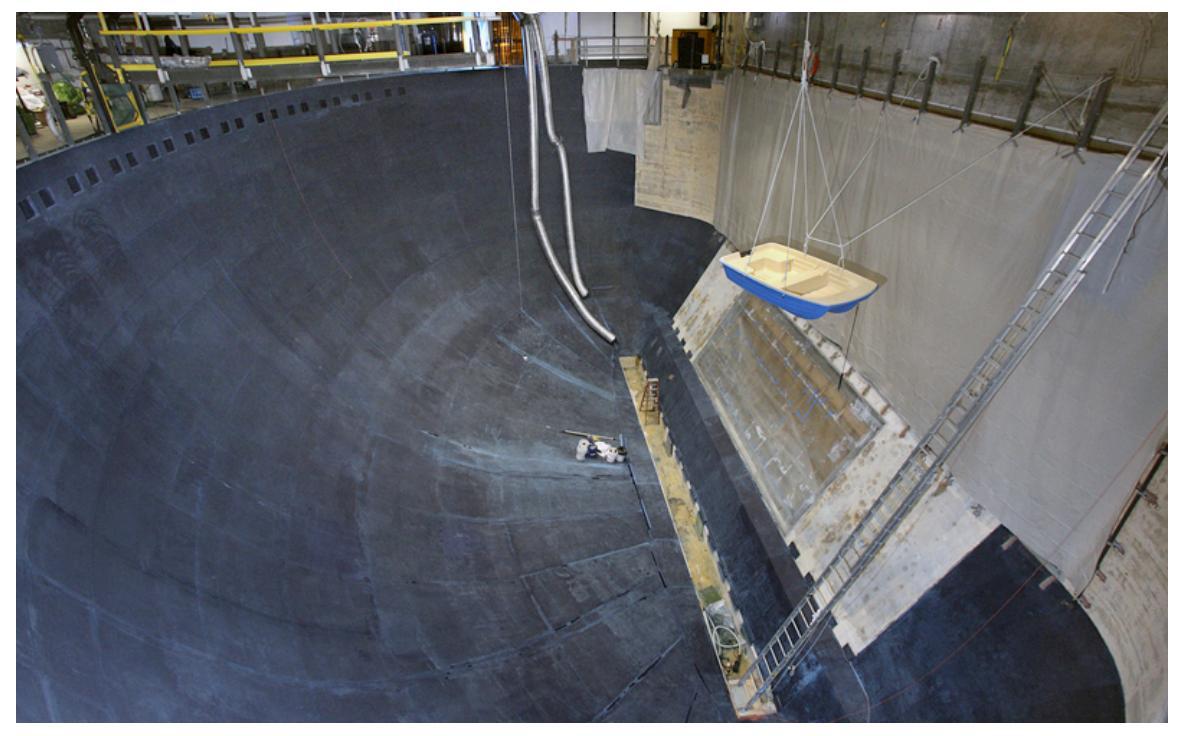
The Monterey Bay Aquarium recently replaced the vast liner of its million gallon tank with a ¼-inch thick, deep blue shell made of fiber reinforced polymer (FRP) composite. It creates the effect of looking into the depth of the open sea, habitat of some of the aquarium's largest animals. The liner's 180 panels were designed, fabricated and installed by Kreysler & Assocs. Here, all the panels had been installed, and were ready for final finishing.

The Monterey Bay Aquarium in Monterey, CA recently replaced the vast tankliner in its million_gallon Open Sea exhibit. The 80-foot-long eggshell of ¼"-thick Fiber Reinforced Polymer (FRP) is the "scenic backdrop" of the tank, designed to create the effect of looking into the featureless depths of the sea.

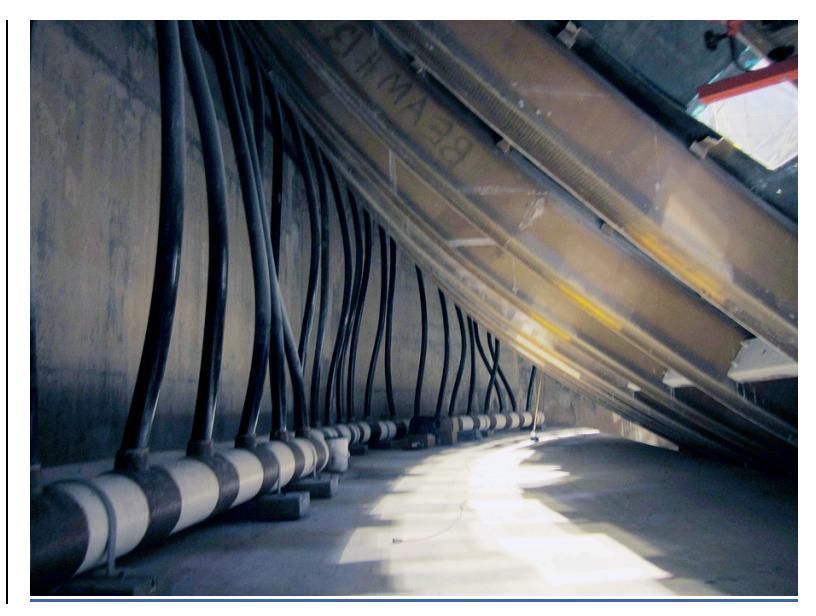
The large support ribs of the liner, seen here from the rear side, are also made of FRP. The original ribs were able to be reused for the new liner, even after 15 years in the water.

However, K&A had to design and fabricate the liner without emptying the tank to measure the installation, since the "jobsite" was still occupied by a million gallons of water and a host of animal residents. The plan called for re-using the original support structure, but K&A did not have direct access to its exact dimensions and curvature. The original, documented dimensions of the support ribs could not be relied upon either, because 16 years under heavy load would have predictably caused them to sag and reshape.

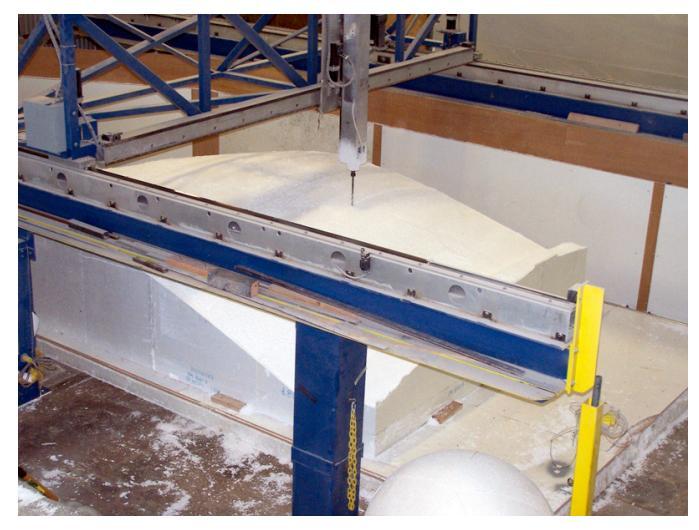
The computer-designed curves of each section of liner were accurately carved onto expanded polystyrene (EPS) foam blocks by this large, gantry-mounted Computer Numerically Controlled (CNC) router. The EPS foam served as a mold to build up the multi-layered FRP composite shell.

Many of the sections were on the order of 10 X 12 feet. They were shaped on molds made of large blocks of expanded polystyrene (EPS) foam. The EPS foam itself was shaped by a gantry-mounted Computer Numerically Controlled (CNC) milling machine that used the 3-D computer model as a guide to nibble down the EPS to precise curves. Sheets of FRP were molded over a period of three months.

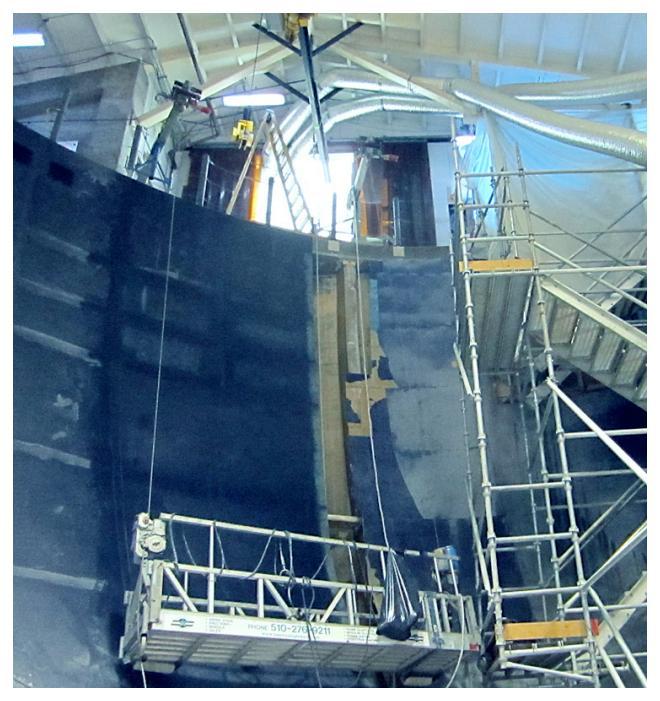
Swing-stage scaffolding like this was used to install the new FRP panels on the existing rib structure.

When all the pieces were ready, panels were transported to the site, the tank was emptied, and the animals sent to board elsewhere. Building scaffolding in the tank to support the installers was not an option because there was no place for it to stand: the bottom of the shell's curve covered the floor. The panels were installed using swing-stage scaffolding hanging from service slab above. During the final finish work, however, the installers stood on a floating work platform that rose as the tank was filled.

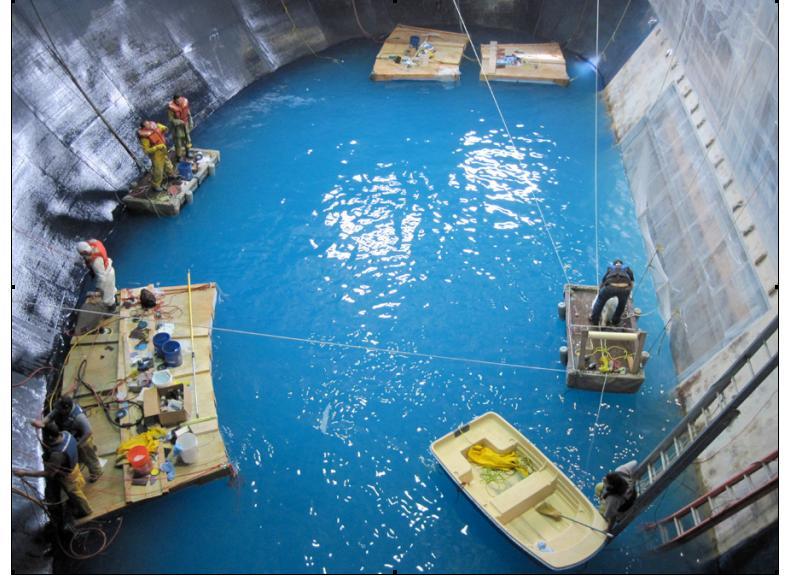
Installers used floating platforms to do final finishing on the 1/4" thick shell. The color effect of the liner, when seen through water, is quite striking. The plastic sheeting on the upper right covers the main viewing window of the tank.

After 4 months of installation, the liner was completed. Following weeks of refilling and reconditioning the water, the animals were slowly introduced back into the exhibit, which was ready to reopen for the July Fourth weekend, 2011.
